Name Of Dam: LAKE MONTCLAIR DAM
Location: PRINCE WILLIAM COUNTY
Inventory Number: VA. 15302

PHASE I INSPECTION REPORT

Lake Montclair Dam. Inventory Number:
VA-15302. Prince William County, Virginia.
Phase I Inspection Report.

MARCH 1979

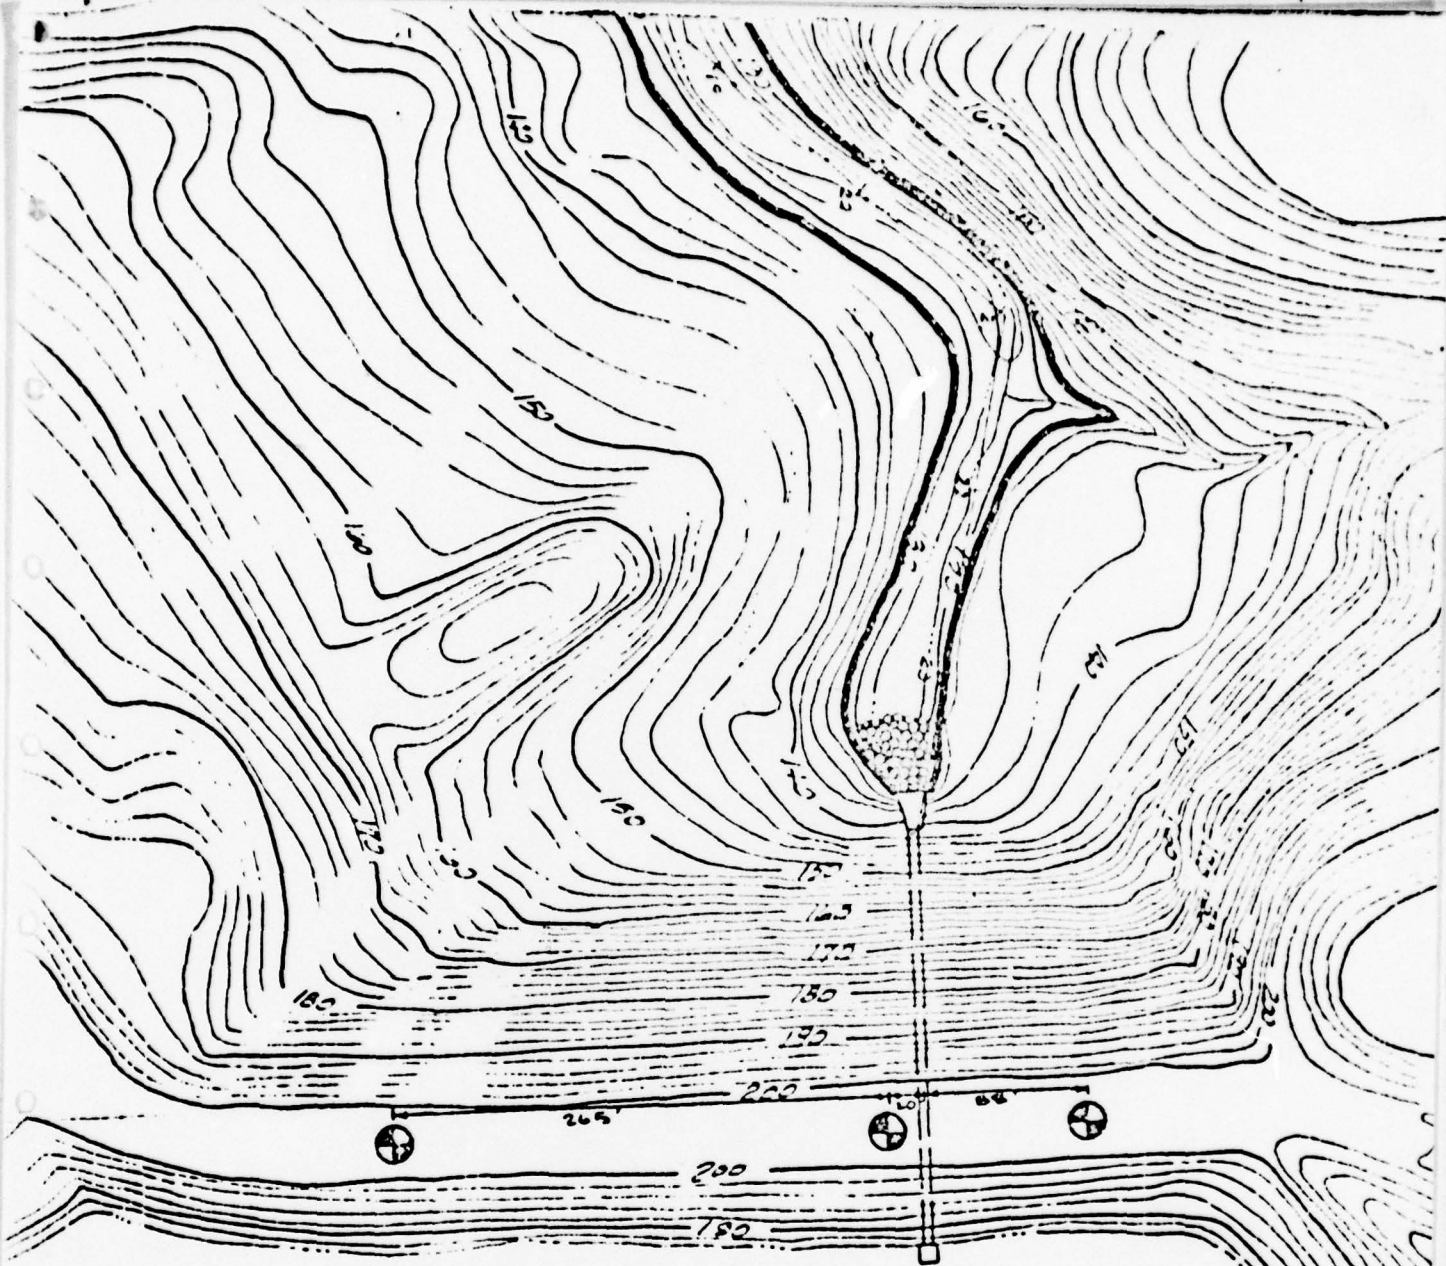
TEST HOLE LOCATION
AUG. 1970, SCALE 1"=100
